Analysis of Non-Motorized Travel Conditions on the Jogoo Road Corridor in Nairobi

Winnie Mitullah and George Makajuma,

4th International Conference of Future Urban Transport, Göteborg

19 April 2009

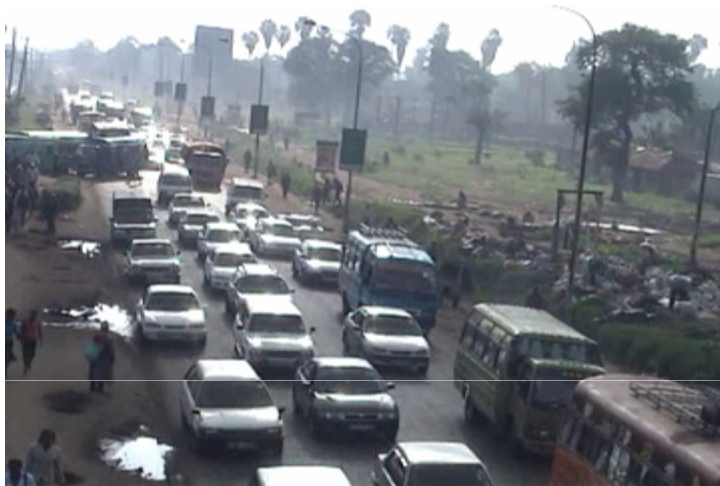
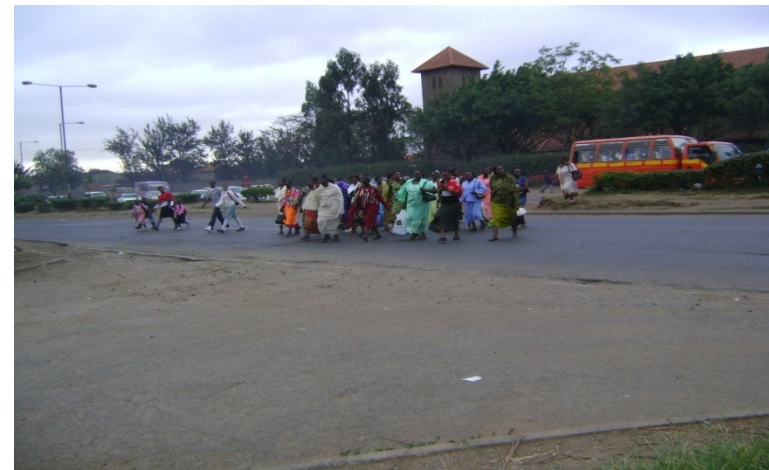
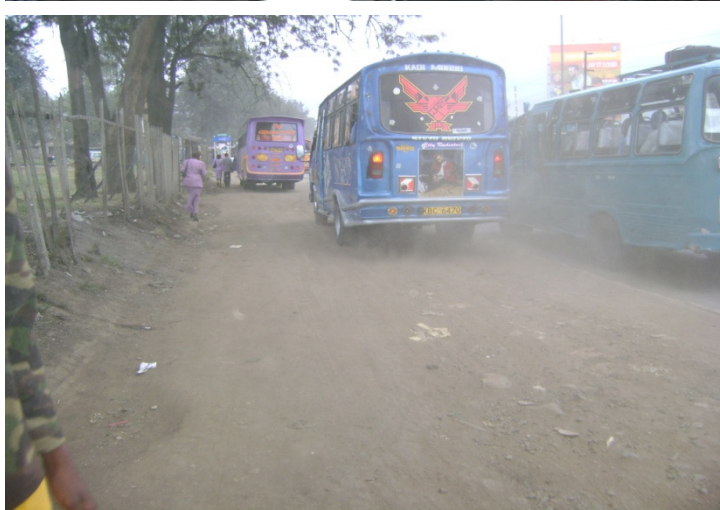
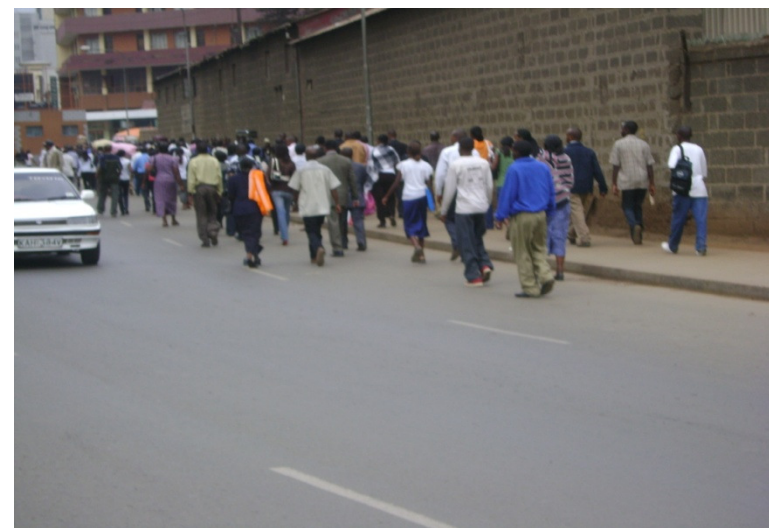
Pictorial view of NMT operating conditions on Jogoo road

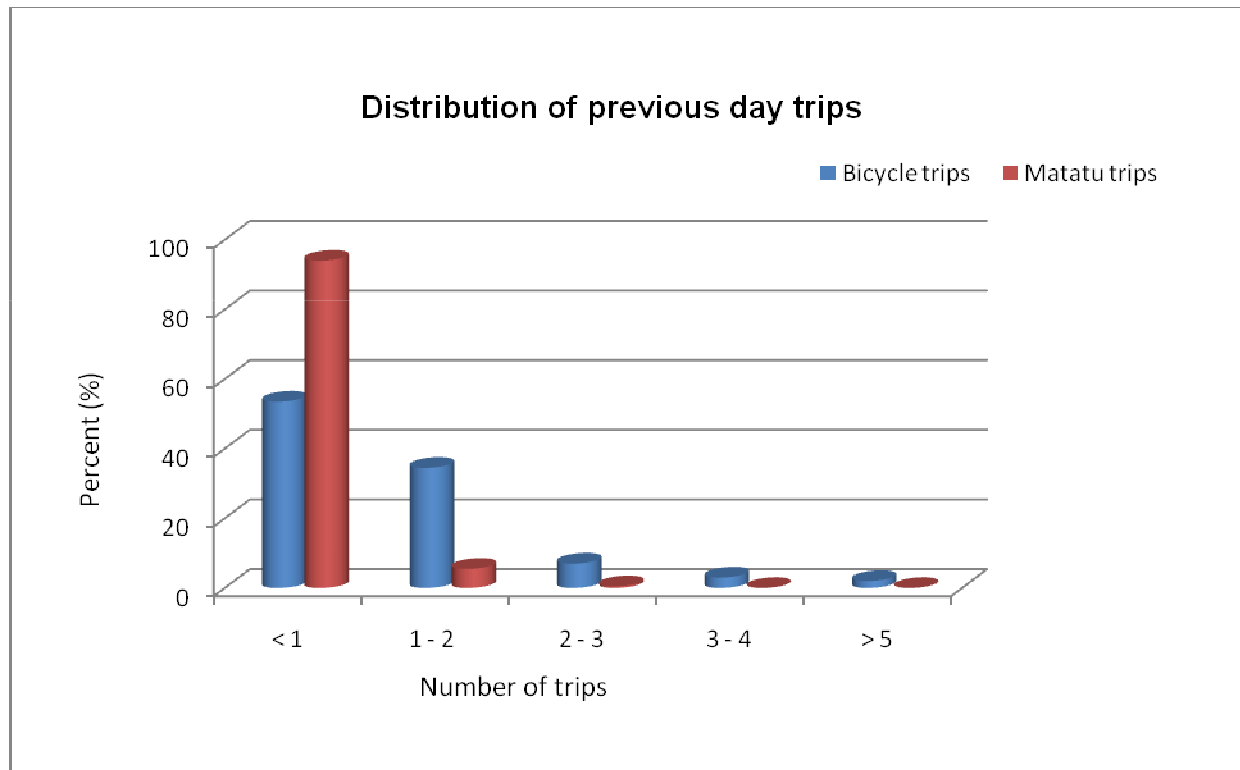
Distribution of daily trips on Jogoo Road Corridor

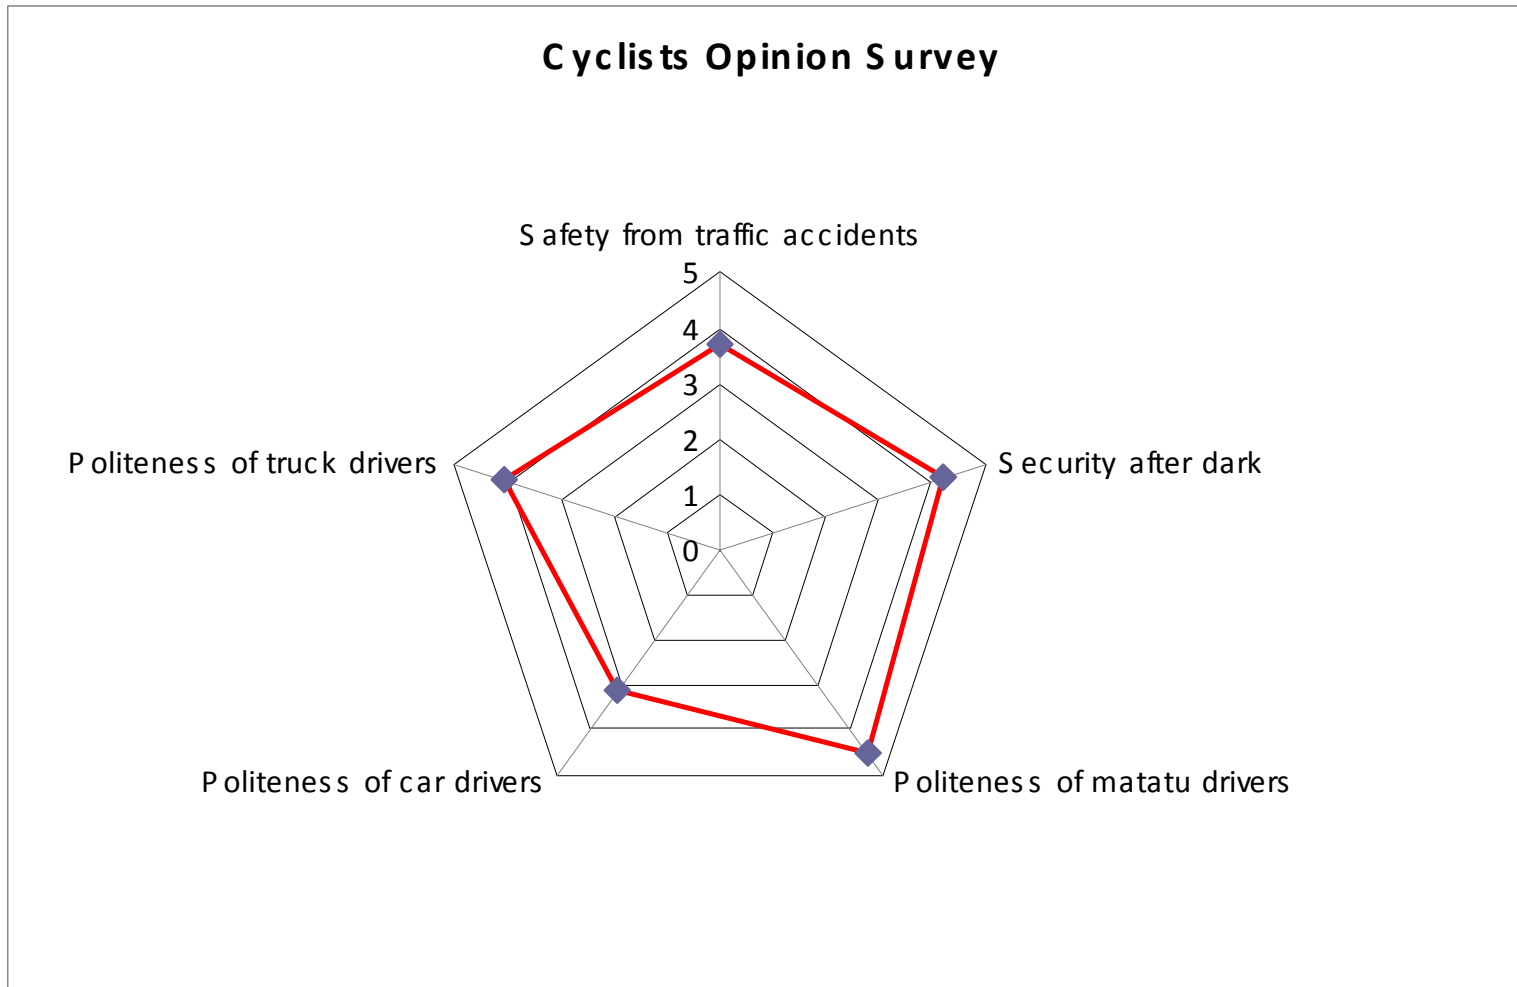
Operating conditions as perceived by cyclists on Jogoo Road Corridor

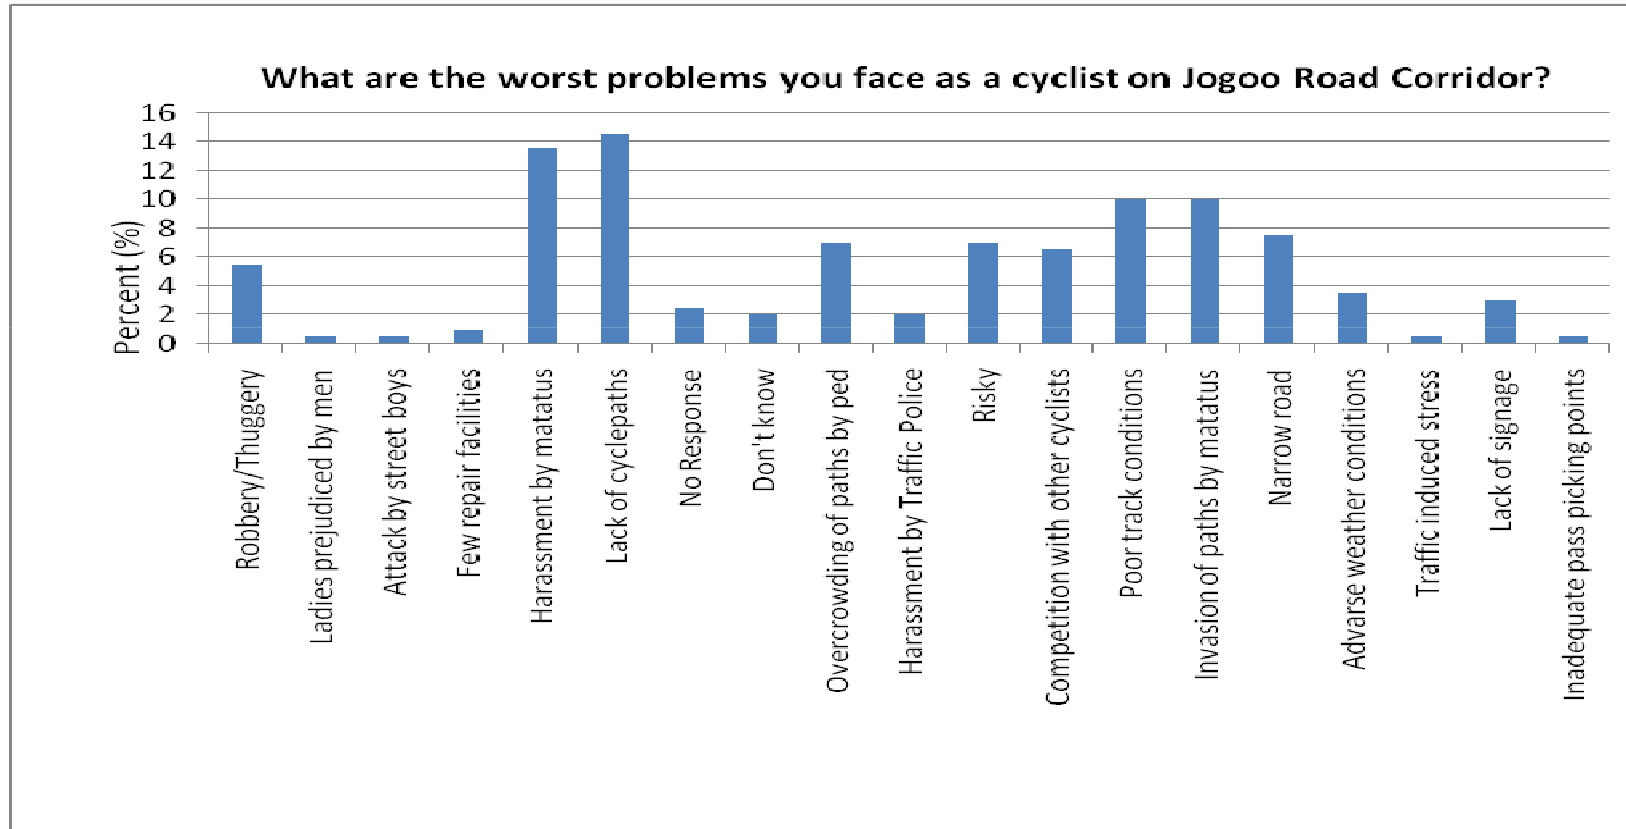
Worst problems cyclists face on Jogoo Road
